**IN-SITU CHEMICAL OXIDATION  
REMEDIAL ACTION REPORT  
ADDENDUM #1**

**CTS OF ASHEVILLE, INC. SUPERFUND SITE  
235 Mills Gap Road  
Asheville, Buncombe County, North Carolina  
EPA ID: NCD003149556  
Consent Decree – Civil Action No. 1:16-cv-380  
NCDEQ UIC Tracking No. WI0100571**

**WSP Project 6252-16-2012**

**December 15, 2023**

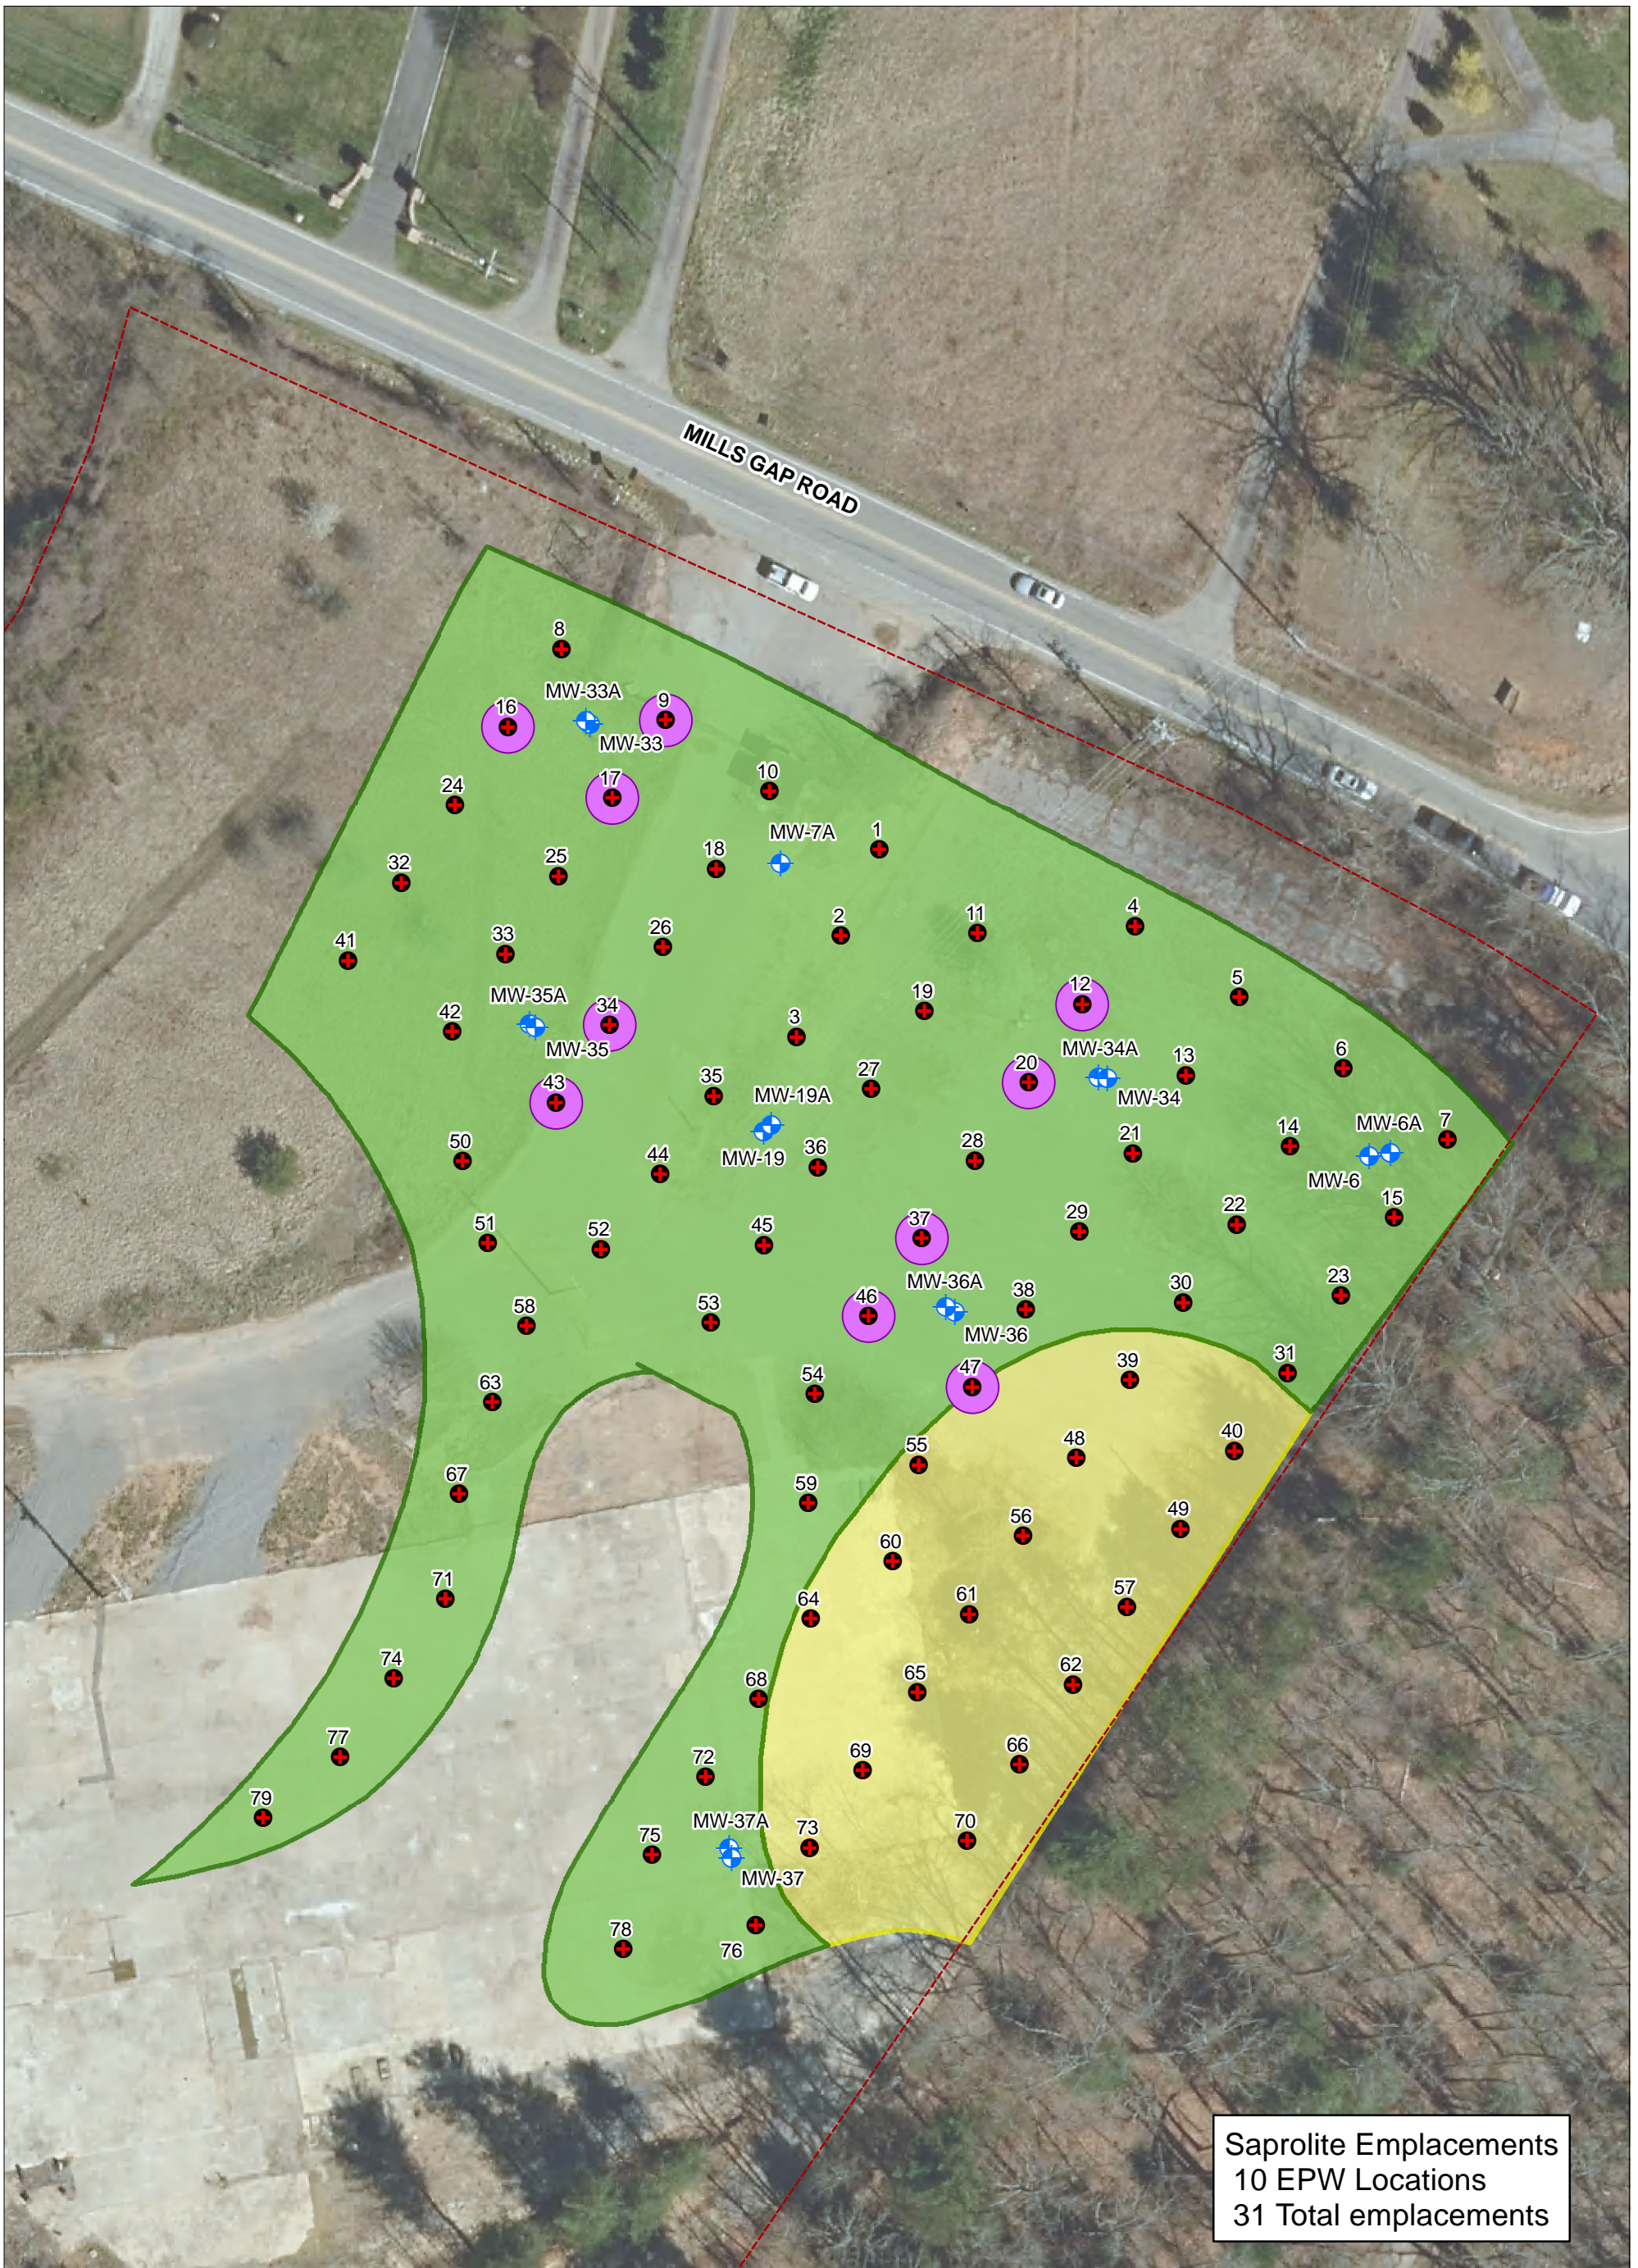
TITLE:  
**SAPROLITE  
 EMPLACEMENT LOCATIONS  
 CTS OF ASHEVILLE, INC.  
 SUPERFUND SITE  
 ASHEVILLE, NORTH CAROLINA**

The saprolite emplacement locations are depicted in Figure 1 and the PWR emplacement locations are depicted in Figure 2. Thirty-two of the 46 emplacements (approximately 70 percent) contained 1,000 pounds of potassium permanganate or greater. The remainder of the emplacements contained at least 500 pounds of potassium permanganate. Table 3 contains a summary of the emplacement mass and volumes. An NCDEQ Injection Event Record is included as Appendix A.

Sapolite Emplacements  
 10 EPW Locations  
 31 Total emplacements

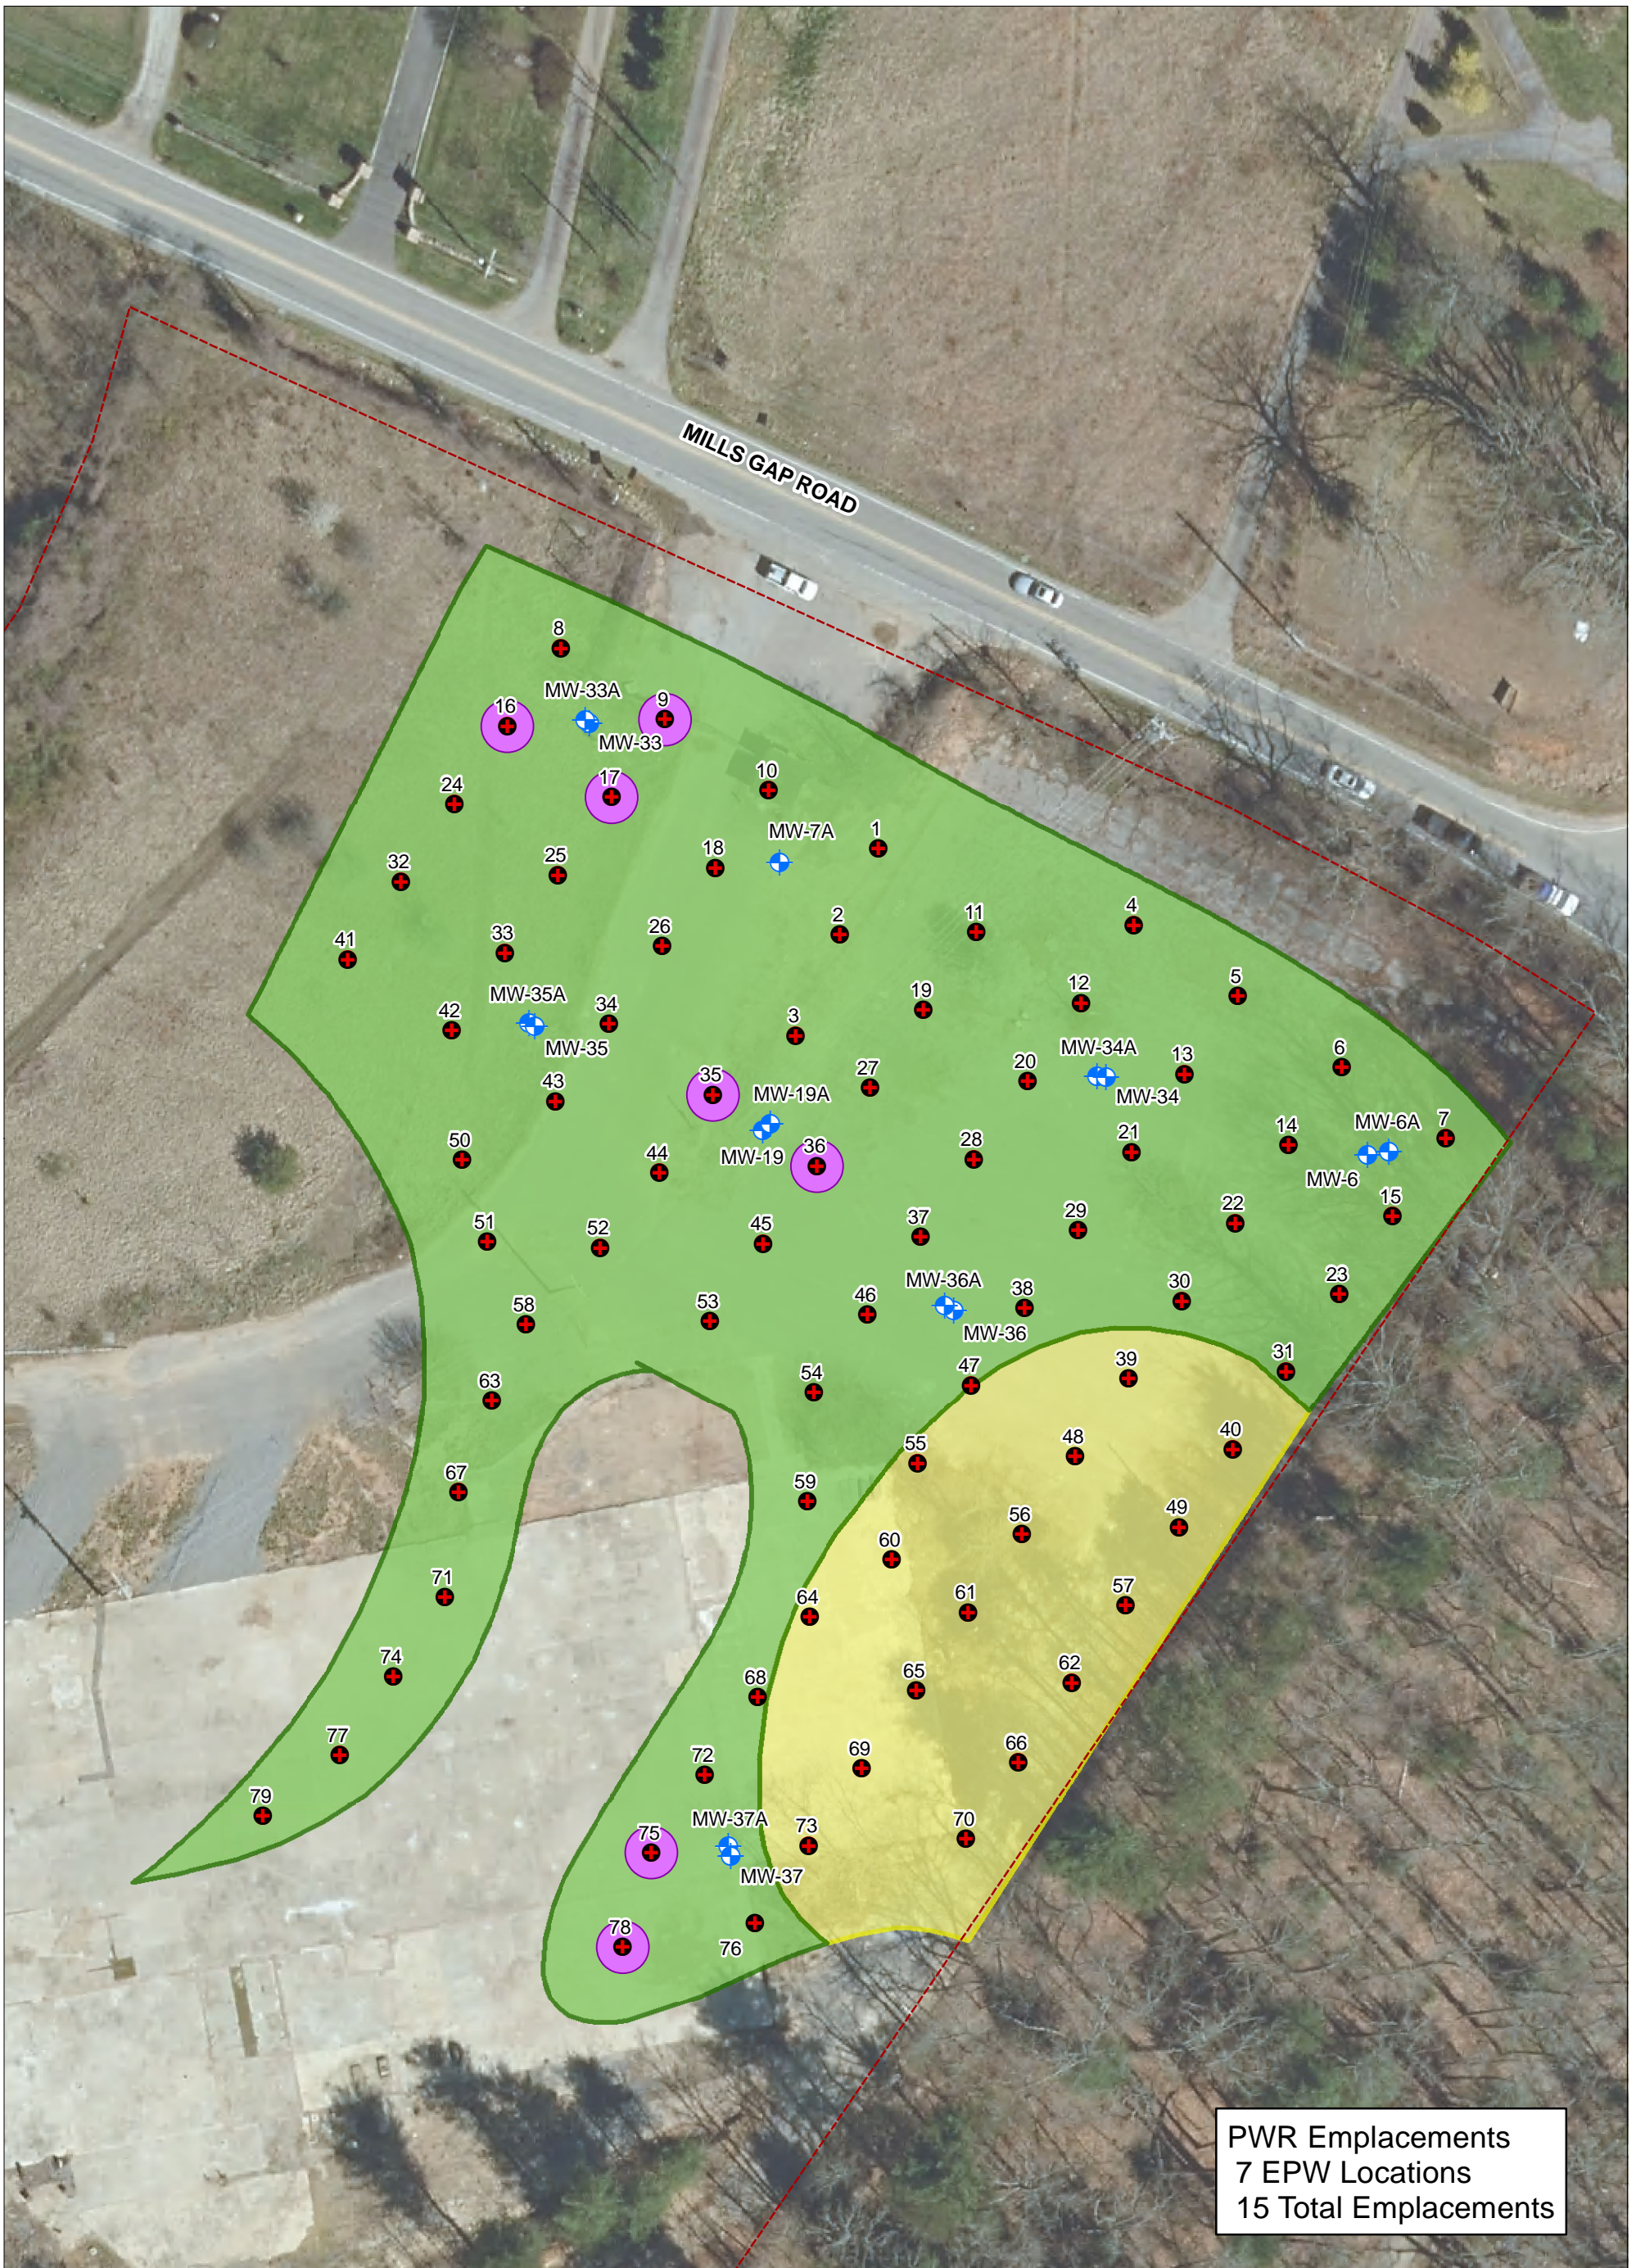
TITLE:  
**PARTIALLY WEATHERED ROCK EMPLACEMENT LOCATIONS**  
**CTS OF ASHEVILLE, INC.**  
**SUPERFUND SITE**  
**ASHEVILLE, NORTH CAROLINA**

PWR Emplacements  
 7 EPW Locations  
 15 Total Emplacements
