# **ELECTRICAL RESISTANCE HEATING MONITORING REPORT**

## **CTS OF ASHEVILLE, INC. SUPERFUND SITE**

**235 Mills Gap Road  
Asheville, Buncombe County, North Carolina  
EPA ID: NCD003149556  
Consent Decree – Civil Action No. 1:16-cv-380**

**March 27, 2019**

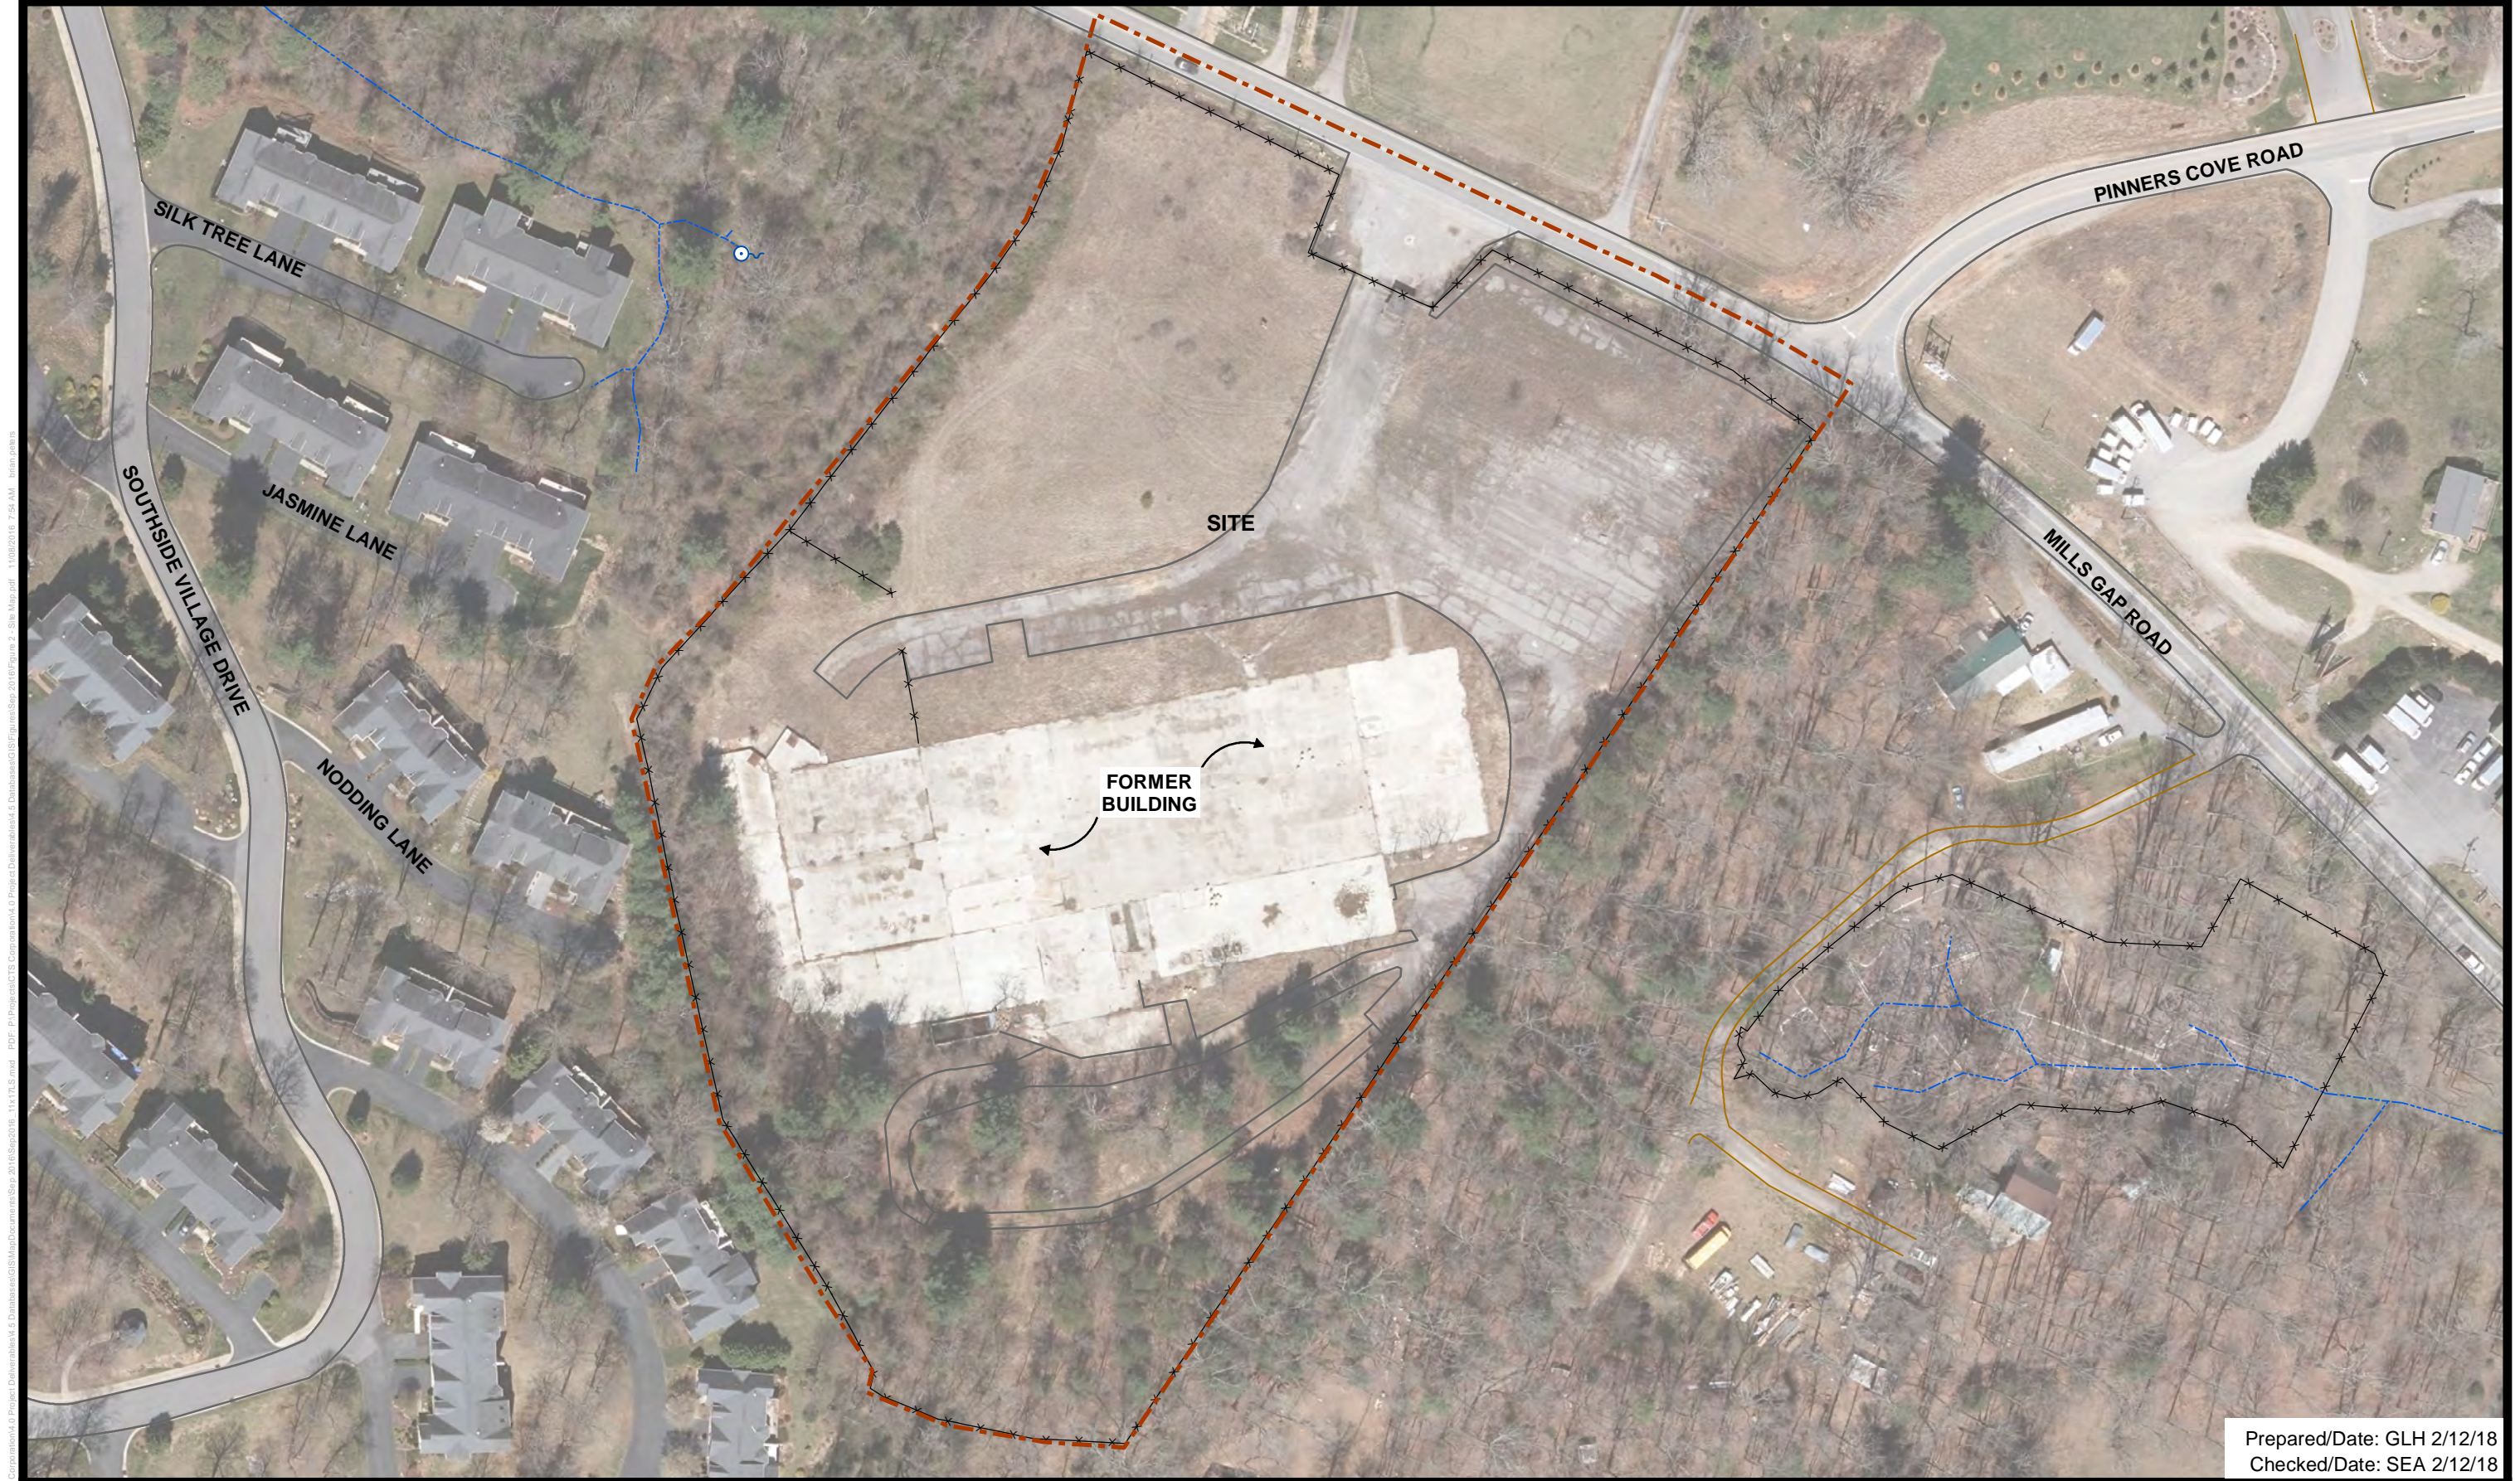
Figure 2

Site Map

The approximate center of the Site is located at north latitude 35°29'36" and west longitude 82°30'25". The Site formerly contained an approximate 95,000-square foot, single-story brick and metal structure on the southern portion of the Site. The building was demolished in December 2011 and the concrete building pad remains intact. The northeastern portion of the Site contains an asphalt-paved parking area, and asphalt-paved driveways are located parallel to the north (front) of the building pad and southeast (rear) of the building pad. A six-foot high chain-link fence surrounds the Site and a locked gate at the north end of the Site controls access to the Site from Mills Gap Road. The Site is unoccupied. The Site and surrounding area are illustrated on Figure 2.
