**FIRST FIVE-YEAR REVIEW REPORT FOR
CTS OF ASHEVILLE, INC. SUPERFUND SITE
BUNCOMBE COUNTY, NORTH CAROLINA**

DECEMBER 2022

**U.S. Environmental Protection Agency
Region 4
Atlanta, Georgia**

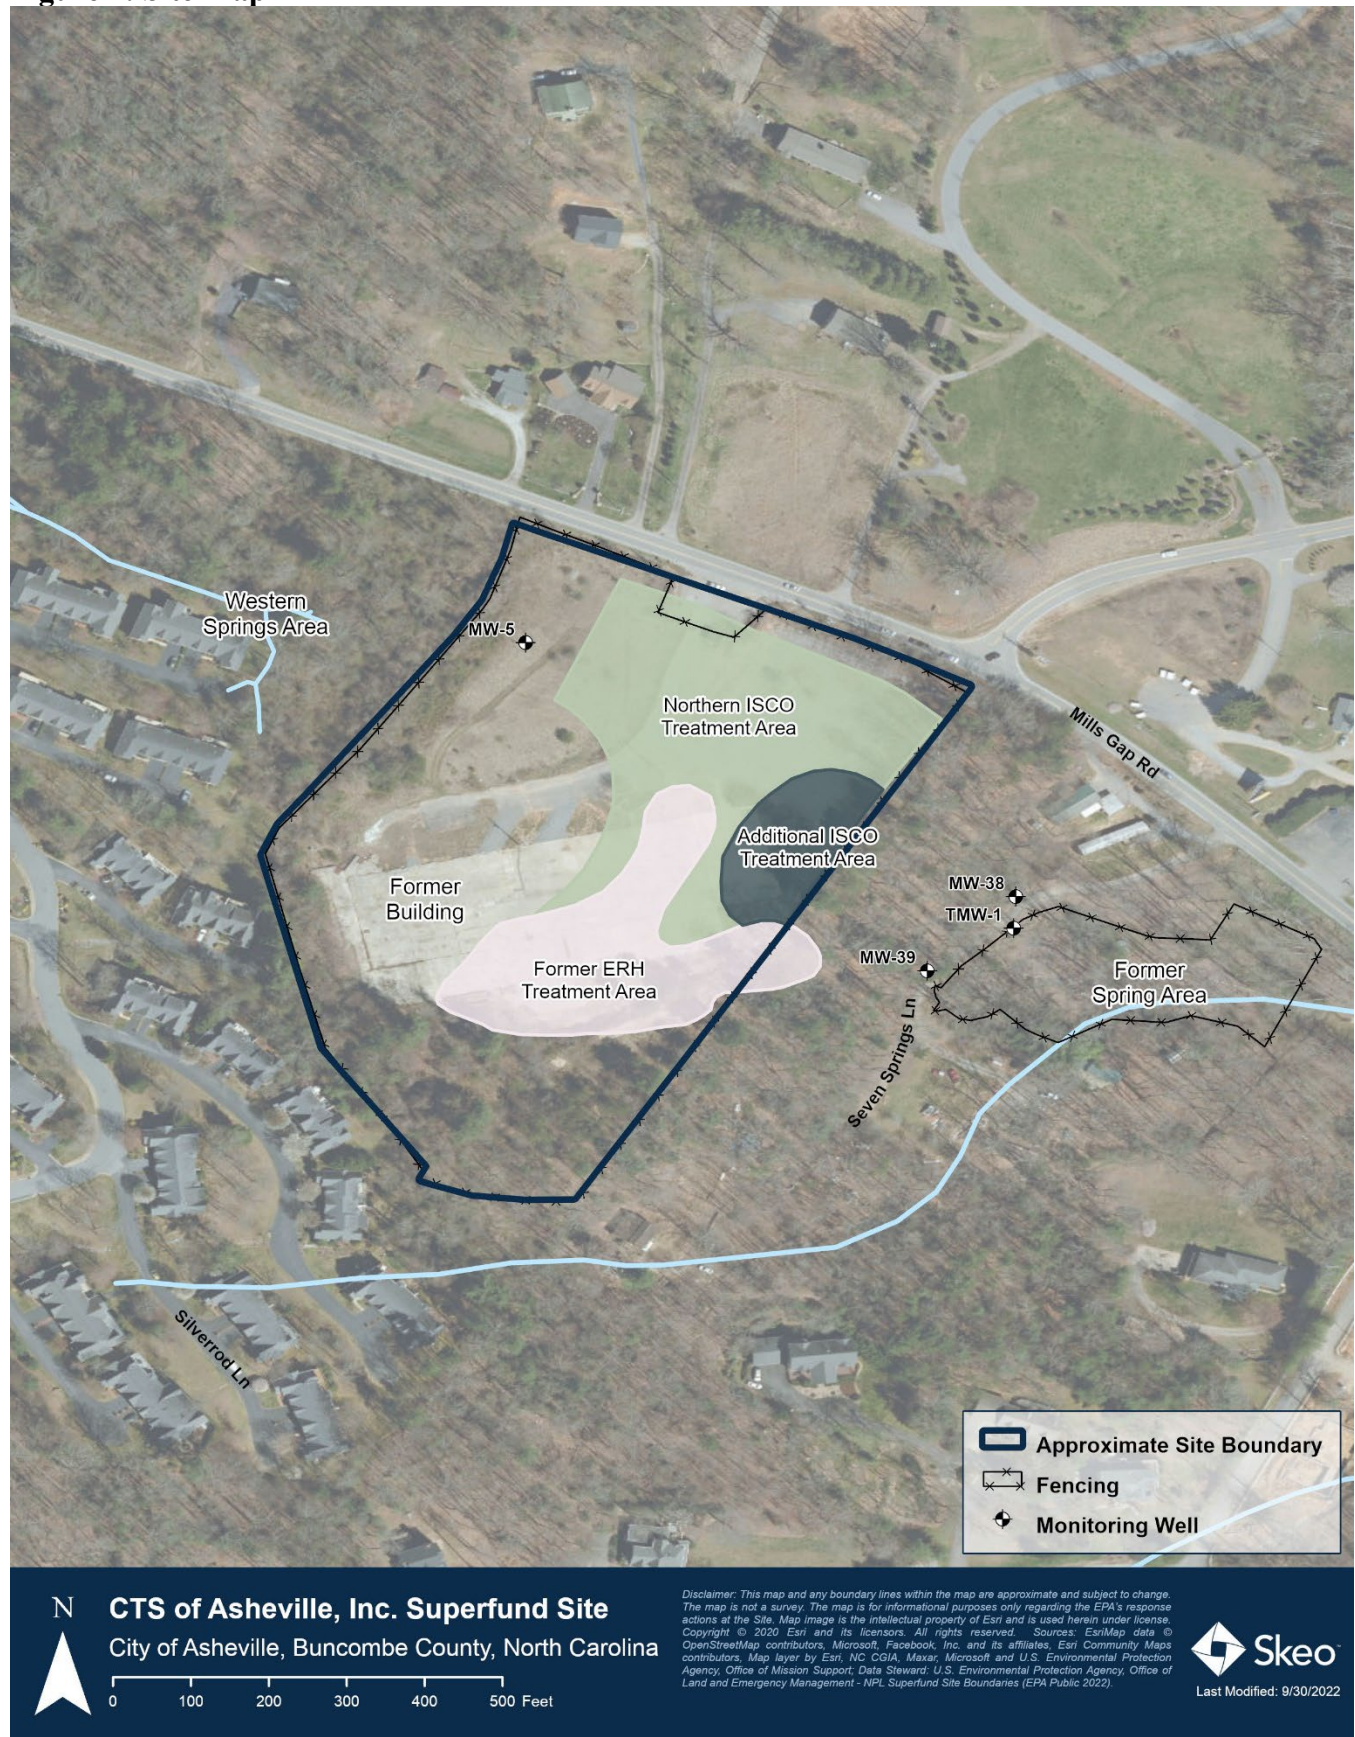
Figure 2: Site Map

In 2016, the EPA signed an Interim ROD selecting a source control interim remedial action for NAPL and TCE on the former CTS plant property. The interim remedial action will be followed up with a final sitewide cleanup decision following assessment of the interim remedy. Figure 2 includes the remedial areas of the Site.

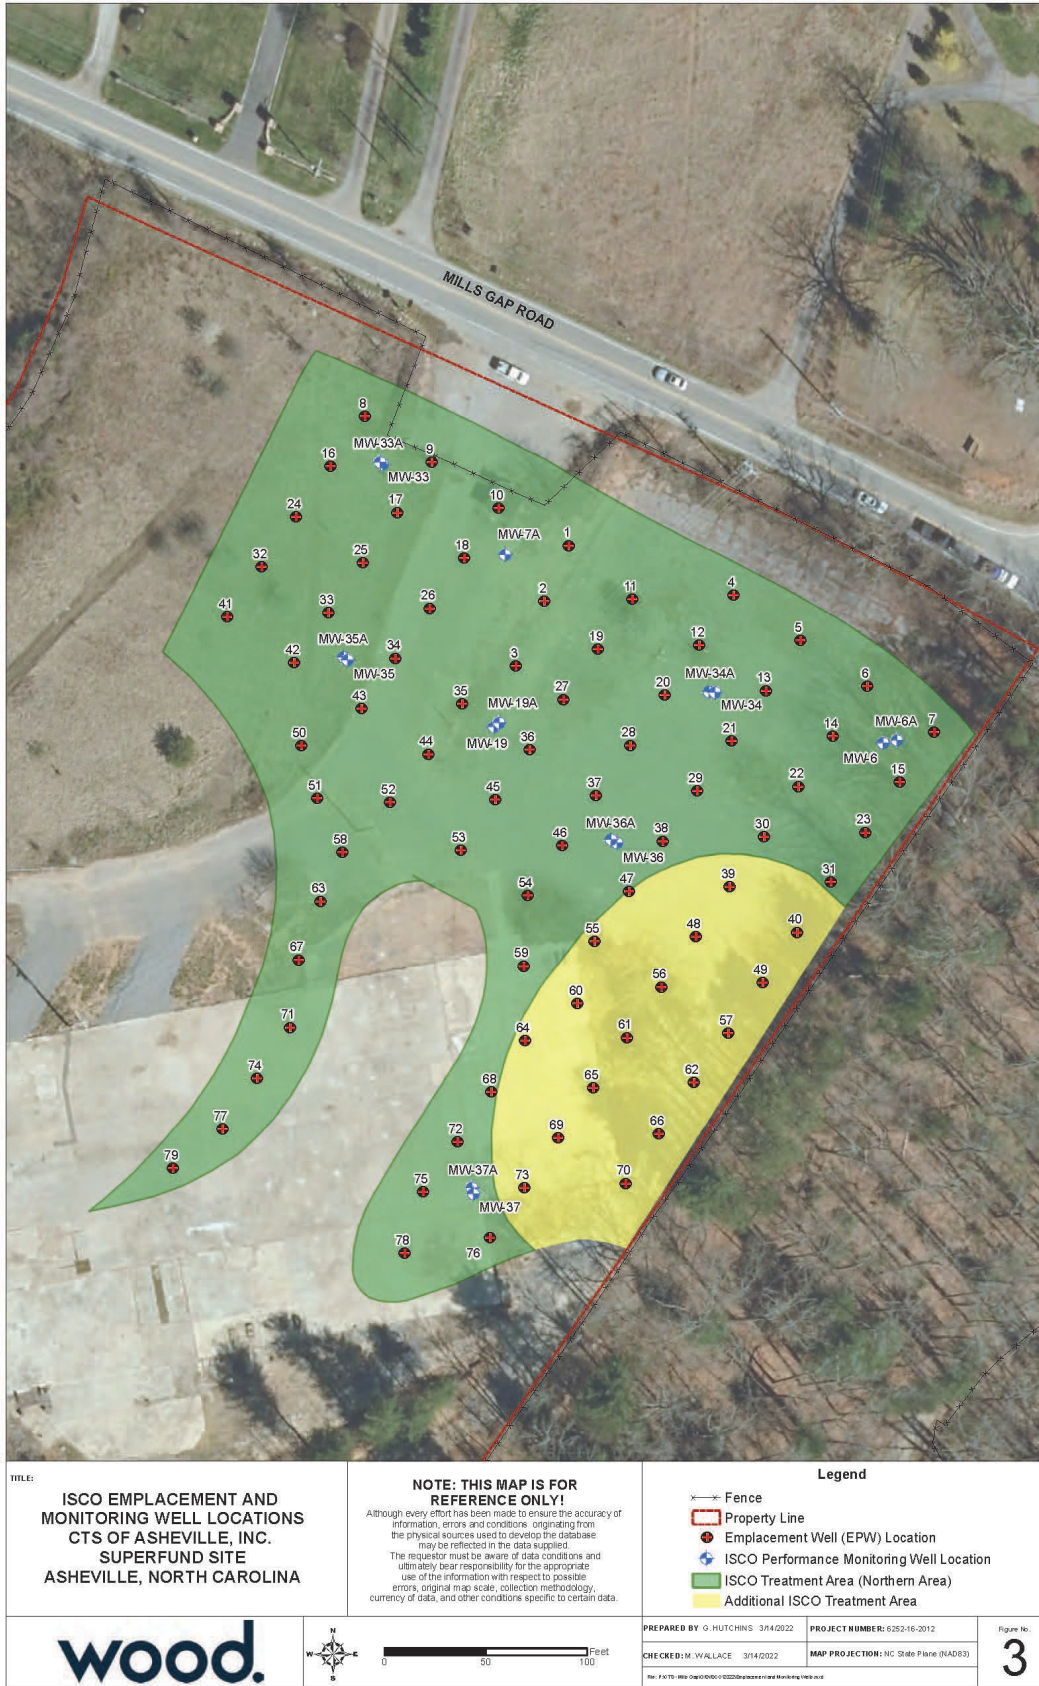
Figure 3: ISCO Emplacement and Monitoring Wells

In general, concentrations of TCE in groundwater samples have decreased significantly compared to baseline concentrations (Table 1). The results of this sampling event indicate the TCE concentrations reported at 8 of the 15 performance monitoring wells were below the RAO concentration. If detected, TCE concentrations in groundwater samples collected from monitoring wells MW-6, MW-6A, MW-7A, MW-34A, MW-35, MW-35A and MW-36A during this monitoring event are less than 5% of the TCE concentrations detected in the respective baseline groundwater samples.

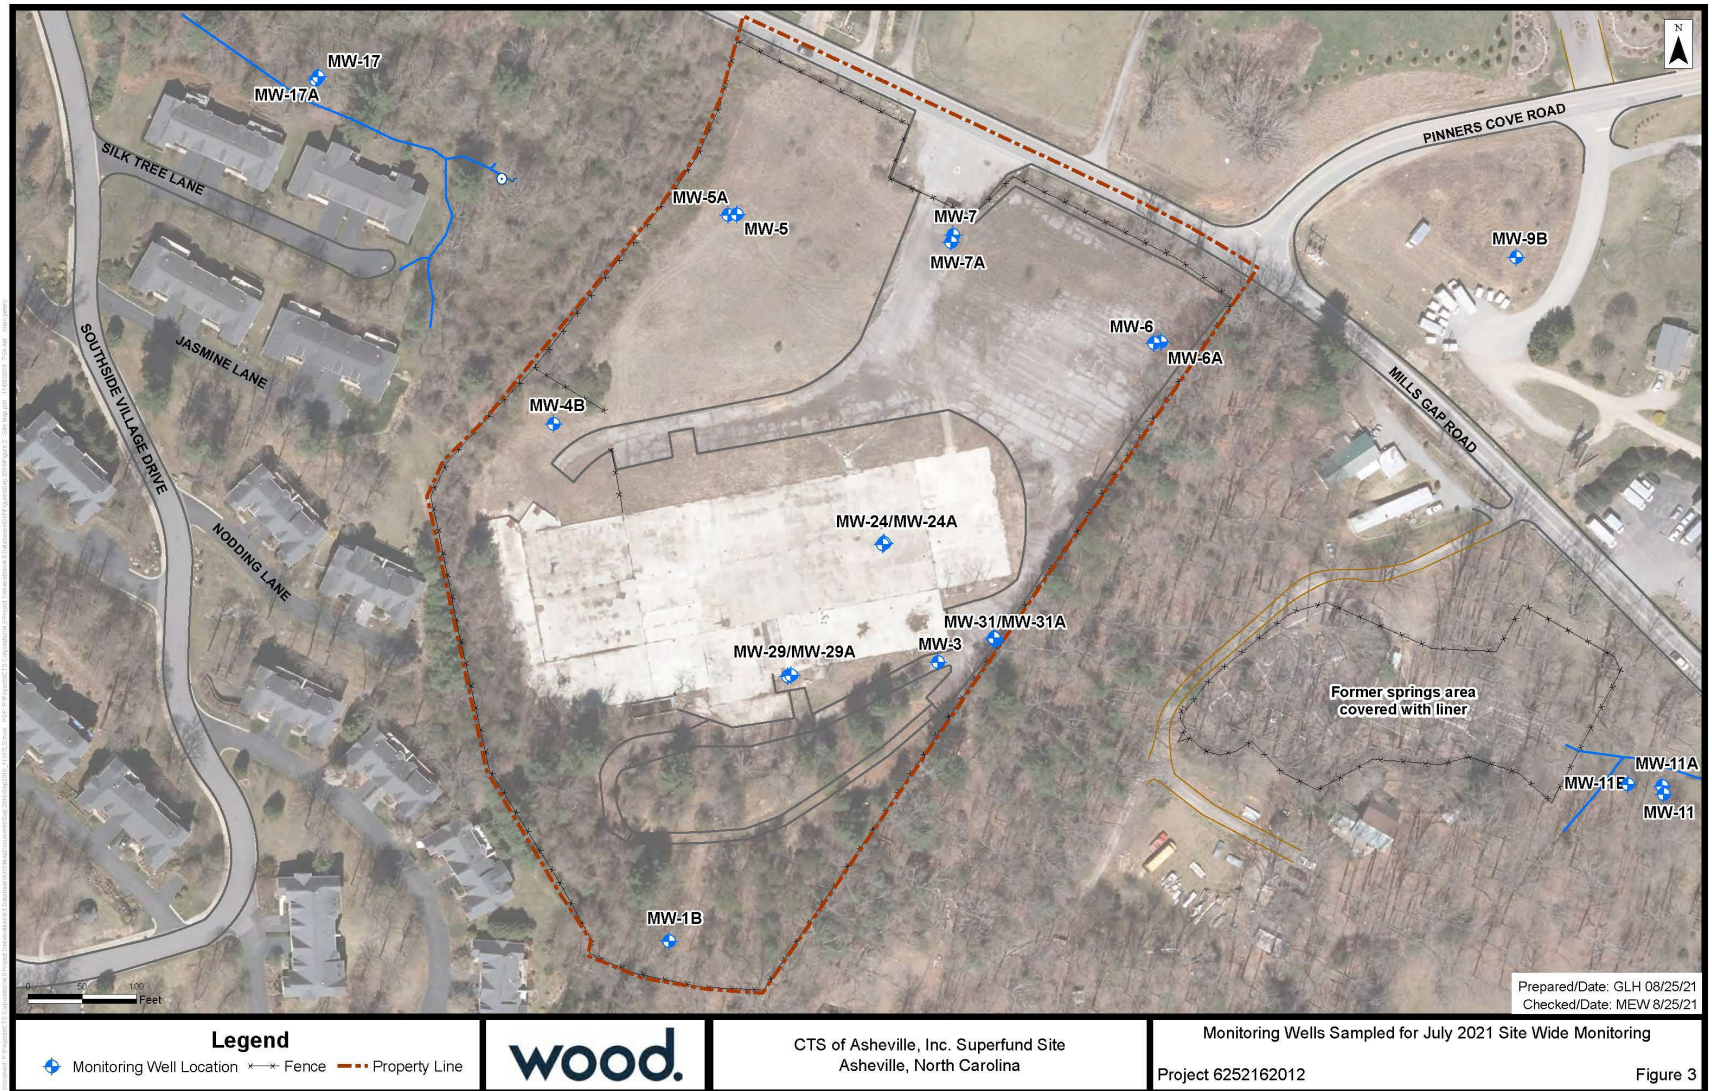
Wood Environment & Infrastructure Solutions, Inc. 1308 Patton Ave Suite C Asheville, NC, 28806 (828)252-8130	TITLE: Shallow Groundwater Elevation, Contour and Flow Map – June 28, 2021		CLIENT: CTS Corporation	Figure <div>4</div>
	SITE: CTS of Asheville, Inc. Superfund Site Asheville, North Carolina		DATE: 8/26/21 DR: GLH LOCATION: PACTS - Mills Gap/IS/Site Wide Monitoring

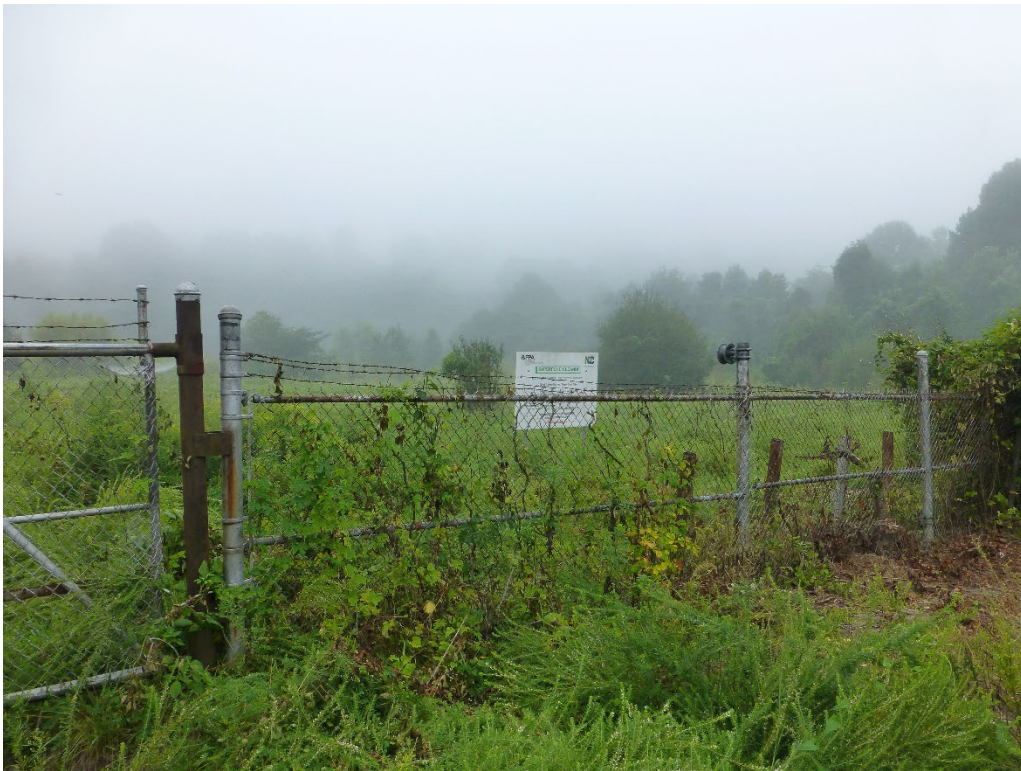
Inspection participants met at the entrance to the Site for a safety briefing prior to walking the site property. The Site remains fully fenced and securely locked. No evidence of trespassing or recent vandalism were found, and O&M contractors noted trespassing has generally not been an issue. On-site wells were located and remain functional. The eastern springs area remains fenced and the liner cover appeared in good condition. The air sparging and carbon system trailer were operational and in good condition. Participants discussed an upcoming road widening project that will bring Mills Gap Road close to the system discharge point. The Department of Transportation is aware of the air sparging system features and are not expected to impact the system operations. Participants then travelled to the western springs area and observed the surface water sampling point. Overall, no issues were noted. The site inspection checklist and photos are included in Appendices G and H, respectively.

Site fencing and gate

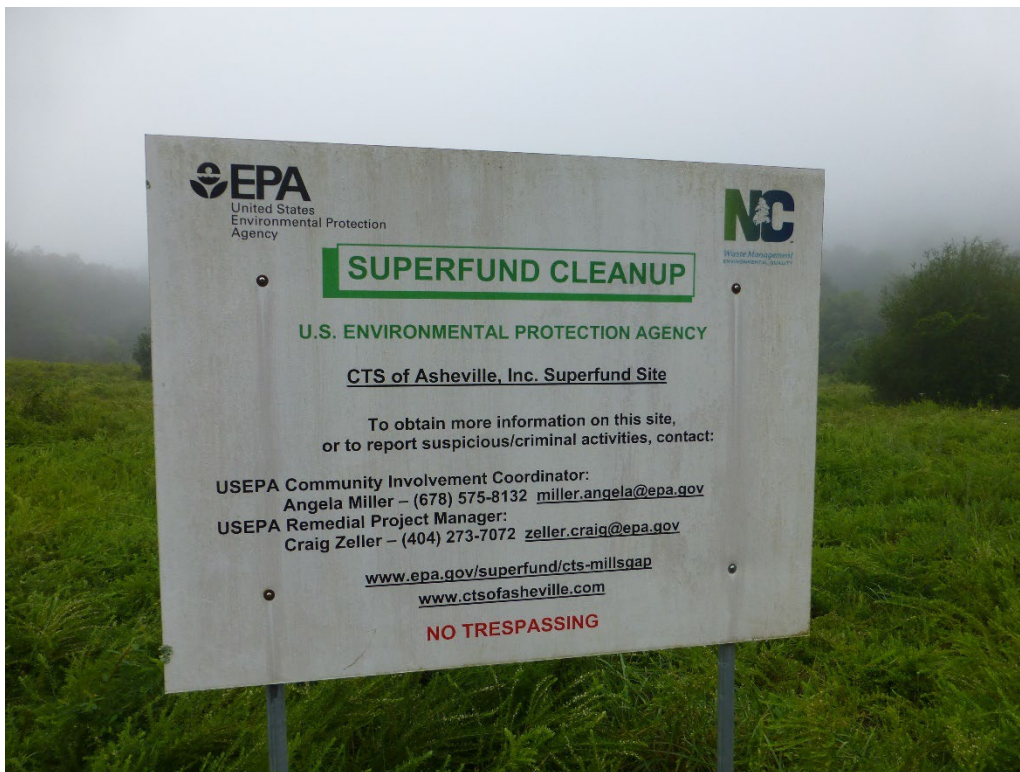
Site signage, inside fencing

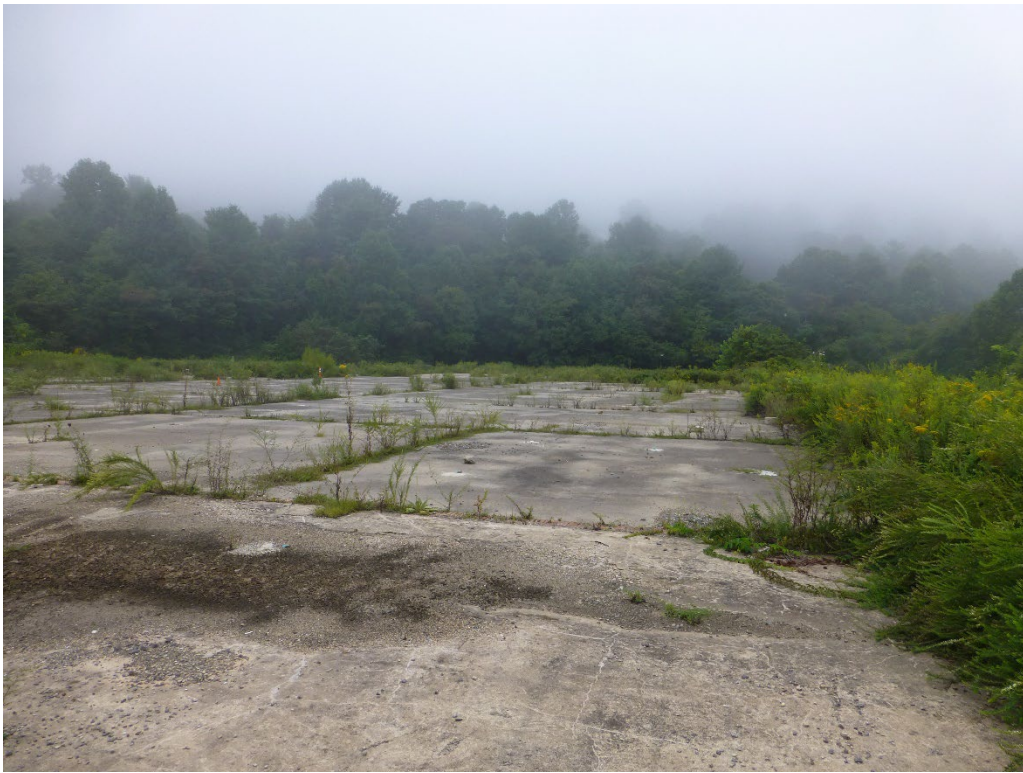
Remaining slab of former building

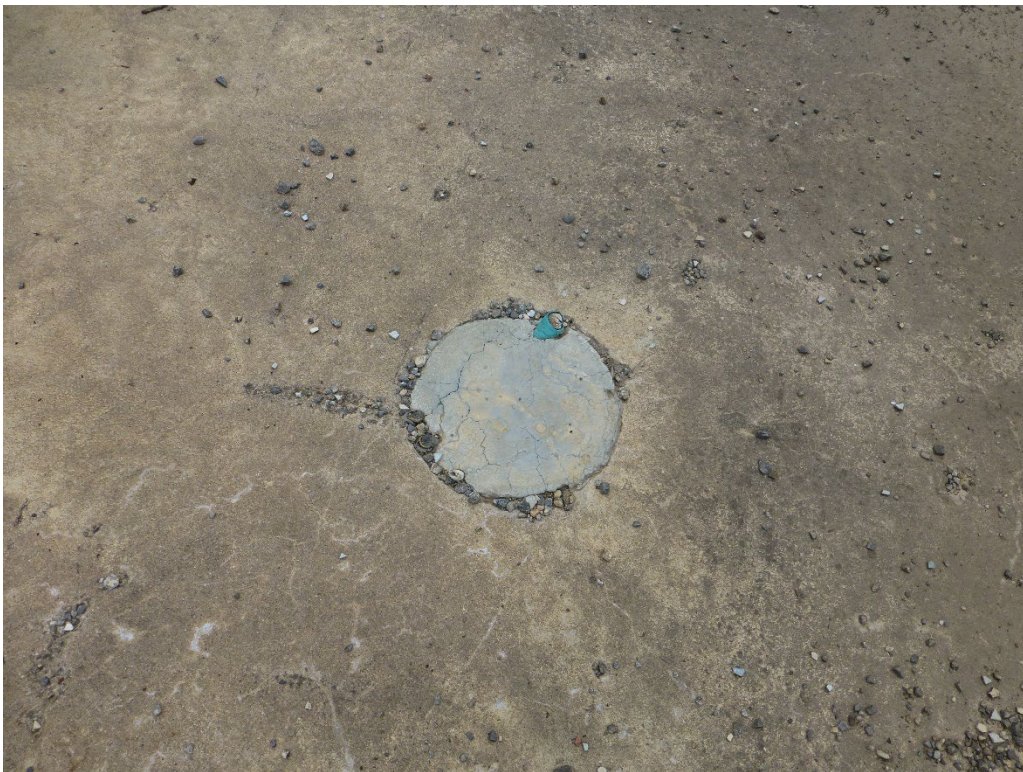
Electrical Resistance Heating Point

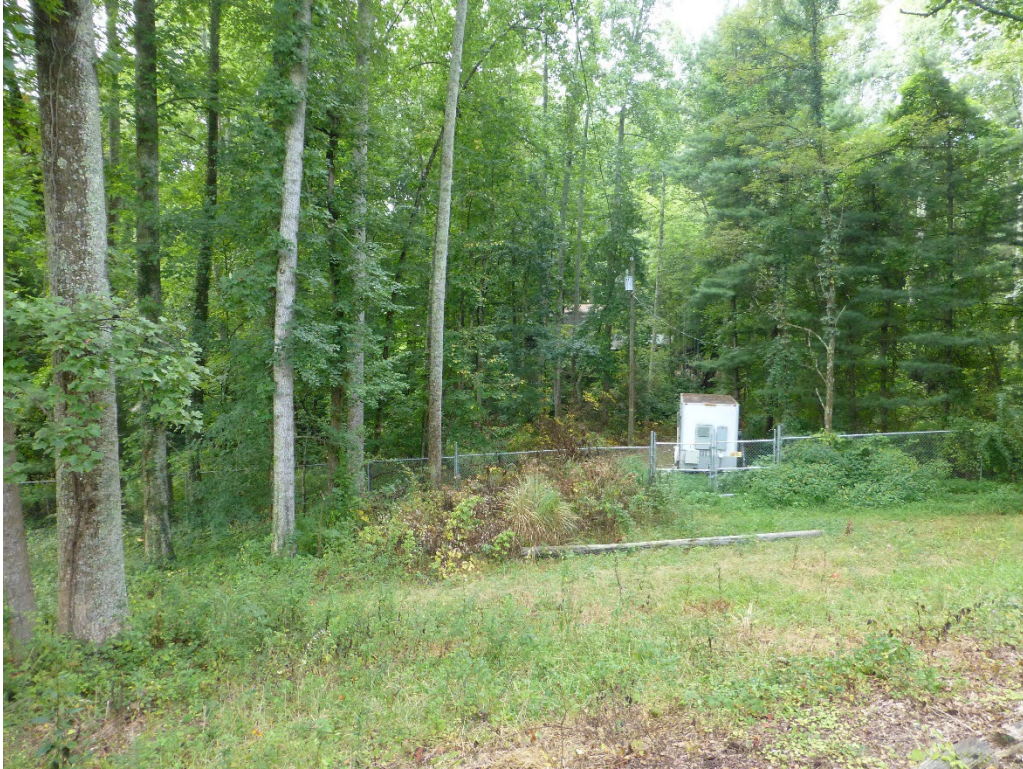
O&M presence is part time, with remote telemetry monitoring/notifications of Eastern Springs Vapor Capture and Removal System operational status. In general, PRP contractors visit the Site at least every two weeks to perform system O&M, site inspections, monitoring and sampling. Operation of the removal action vapor mitigation system at the eastern spring includes regular monitoring of the spring liner condition and operation of the air sparging system. No significant modifications or repairs have been needed since construction. Since initiation, the PRPs completed several enhancements to the system to improve and maintain efficiency.

Eastern Springs Vapor Capture and Removal System

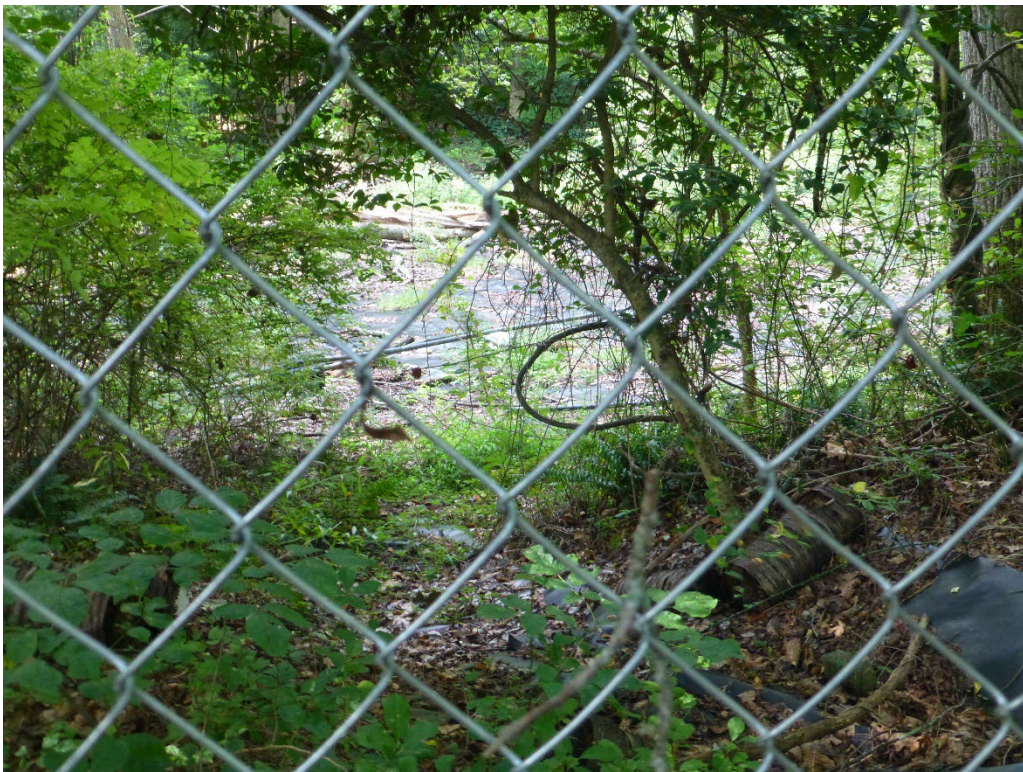
Fencing and polyethylene cover at eastern springs area

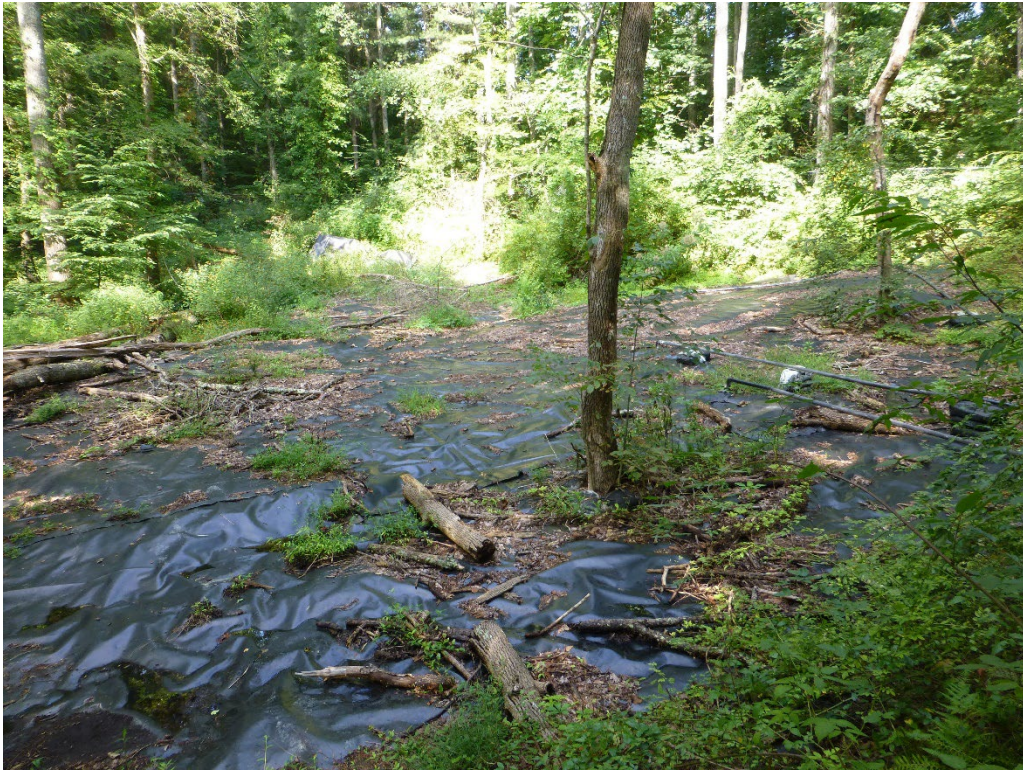
Fencing and polyethylene cover at eastern springs area

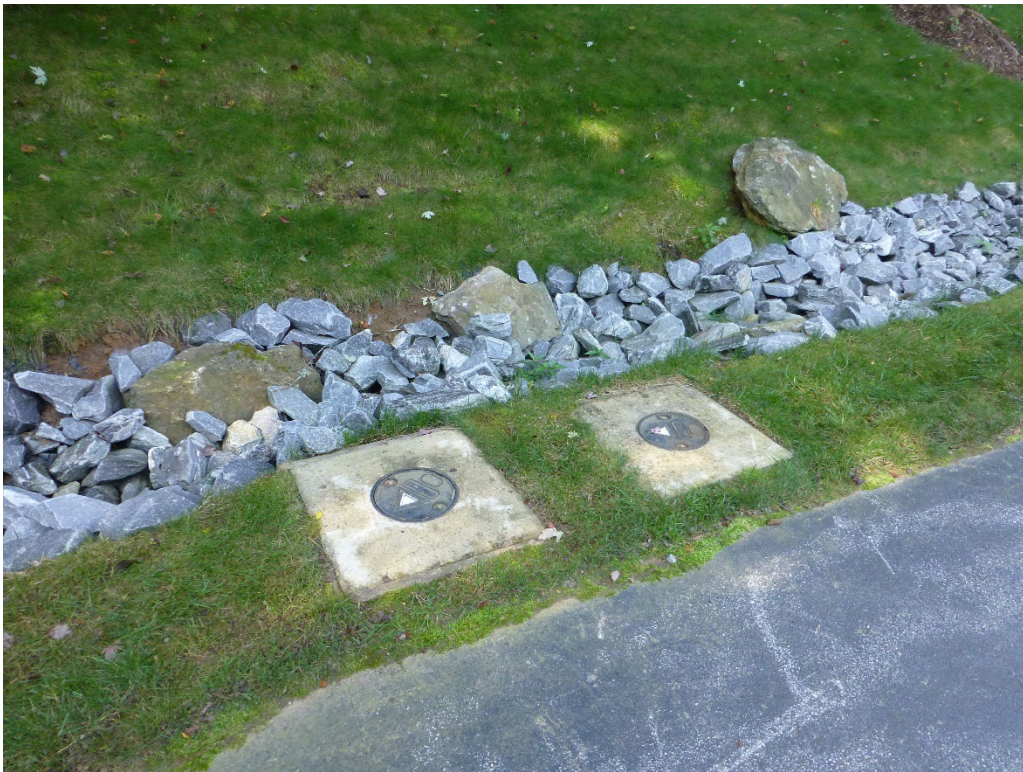
Groundwater monitoring wells
